PRE-CERCLIS SITE SCREENING REPORT

Tannery Sludge Farm Fields Site
Andrew, Buchanan, Clinton, and DeKalb Counties, Missouri

September 30, 2010

Missouri Department of Natural Resources
Division of Environmental Quality
Hazardous Waste Program

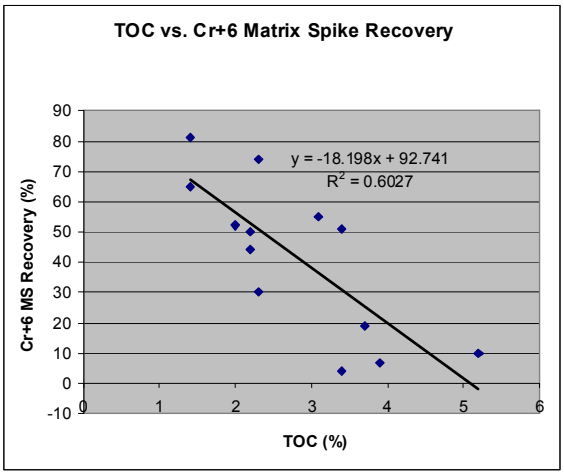
FIGURE 4

Data for these additional analytical parameters were not available for all of the DUs sampled. In order to improve confidence in the ability to determine whether mean [Cr^{+6}] in residential yard soil is below the screening level of 2.0 mg/kg, the sampling team resampled all of the residential yards and analyzed each sample for additional parameters in order to provide supporting multiple lines of evidence. As a further line of evidence, an aqueous Cr^{+6} matrix spike was conducted on *every* residential yard DUIS sample rather than the conventional one per analytical batch. Correlation of low Cr^{+6} DUIS sample results with poor matrix spike recovery and strong soil reducing conditions in both the residential yard and farm field samples would demonstrate that the soil matrix does not support formation of Cr^{+6}. Additionally, a soil reference material containing a certified concentration of Cr^{+6} was used to conduct a solid matrix spike on some of the samples. Failure to recover Cr^{+6} from the solid matrix spike would further support the supposition that the reducing nature of the soils rather than the sample preparation or analytical method are the source of the poor recoveries. The results of these additional quality control measures showed a fairly strong correlation between poor spike recoveries (both liquid and solid spikes) with the amount of TOC in the samples (Figure 4).

This indicates that the reducing nature of the soils, as indicated at least in part by the amount of organic carbon, strongly favor the trivalent form of chromium over the hexavalent form.

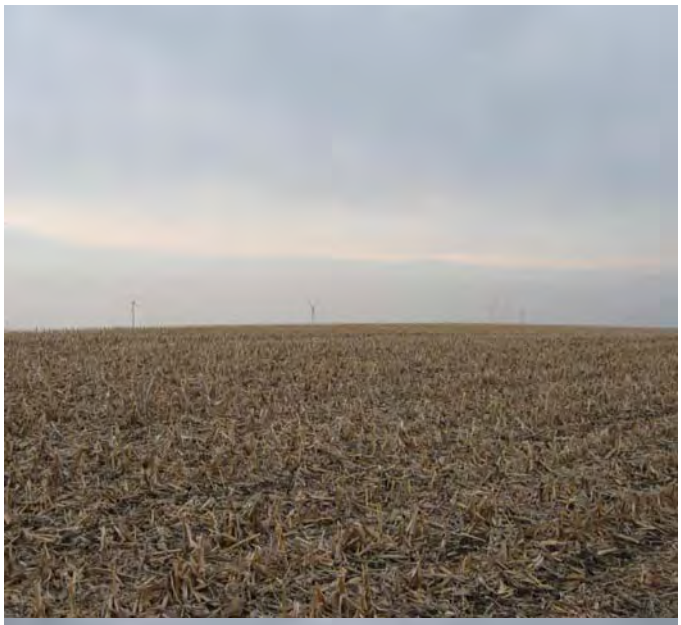
Photograph 6
Tannery Sludge Farm Fields Site
Photo taken 4/6/10 by
Michael Stroh,
DEQ, HWP, SPF

Location ID 251, SU 387.
Background farm field.
Soybean field, uniform upland near gravel road.

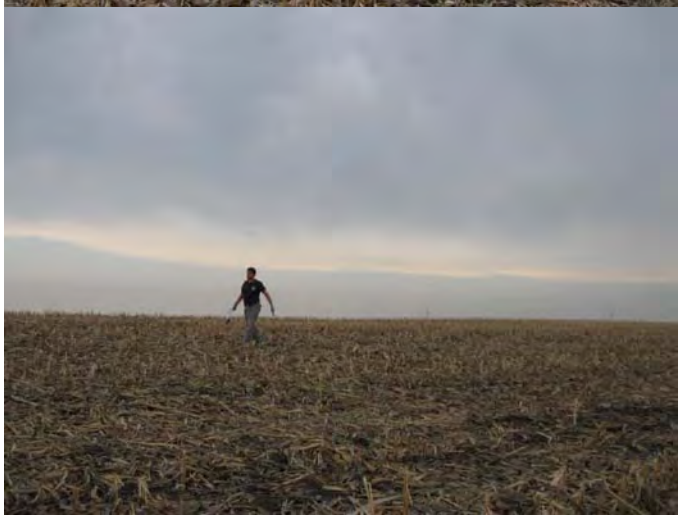
Photograph 7
Tannery Sludge Farm Fields Site
Photo taken 4/6/10 by
Michael Stroh,
DEQ, HWP, SPF

Location ID 221, SU 162.
Target farm field. Uniform corn field with little topography. Selected for triplicate SU QC samples.
